Cracking Under Stress

What causes blade bearing cracks and where to find them before it's too late

by Cory Mittleider

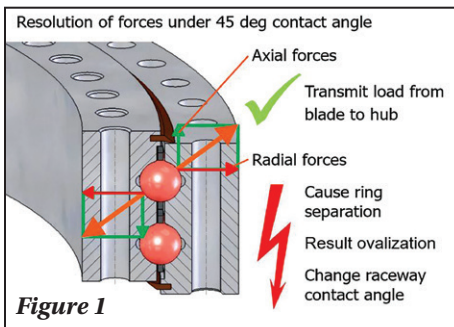
Figure 1

Pitch bearings, also known as blade bearings, connect the wind turbine blade root to the turbine rotor hub. The blade bearings allow the blade position to be optimized at various stages of operation. This includes optimized angle of attack to control drivetrain load, usually to maximize output. In other words, properly functioning pitch bearings are critical to maximize productivity of wind turbine generators (WTGs).

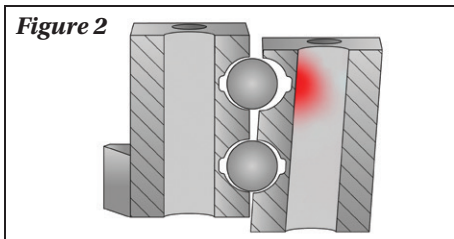
Figure 2

When this bearing type is highly loaded in a pitch application, the highest stress concentration occurs within the bolt holes on the outer ring, just behind the outboard raceway (Figure 2). When the bearing is allowed to deform under load (Figure 3), this emphasizes this stress concentration.

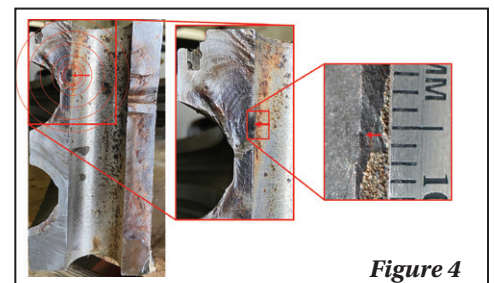
Figure 4

Once the cracked face is exposed, it is easy to see the beach marks, which are a classic indicator of fatigue driven by load cycling. These beach marks can be traced back to a central point (Figure 4). This central point is the initiation point of the crack.

In all the inspections we have performed on cracked bearings, this initiation point

has been found in the same place: in the bolt hole, just behind the blade side raceway. This is the same place that we already know will have the highest concentration of stress.

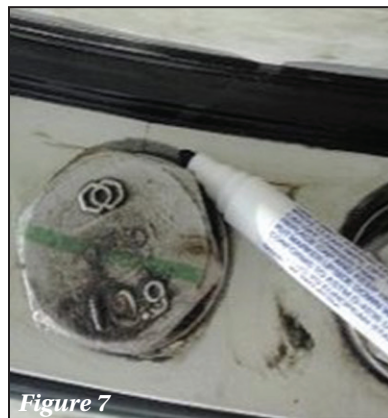
Figure 7

Because the cracks initiate in the outer ring bolt hole, just behind the blade side raceway, and grow in a circular pattern (Seen previously in figure 4), the first external area where a crack should become visible will be next to the seal, just inside of the

mounting hardware (Figure 7).

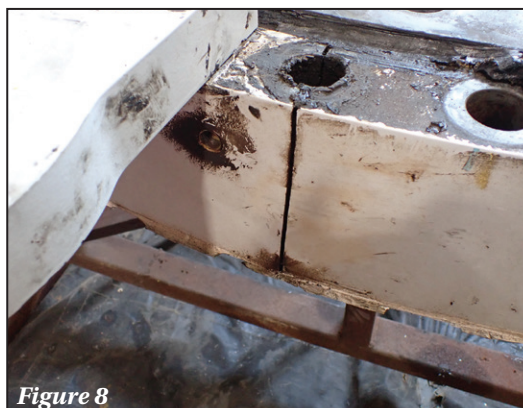
Figure 8

Around the circumference of the bearing, there are multiple areas where cracks tend to form. The most obvious place to look is near sudden changes in system stiffness, such as lifting plates or stiffening plates (figure 8). These plates create a stiffness joint, leading to additional concentration of stress; the bolt hole just outboard of the plate is often a cracking point. We have also seen cracks form near hub entry ports, and other areas without obvious attachments to the bearing that change the structural stiffness of the hub. Cracks through the filling plugs (Figure 9) are also known to happen. These manifest slightly differently than the cracks found through bolt holes, but ultimately have the same consequences, and need to be addressed immediately when found.

It is critical to the safety of personnel working in and near the turbine that cracked blade bearings be identified early, and shutdown, before additional damage to equipment puts their safety at risk. It is hard to predict the rate at which a crack will grow – if a crack is found, the turbine should be removed from service immediately. The eventual failure mode of a cracked bearing is the blade falling from the turbine.
